Manhole Inspection Summary

Manhole # S49C__007MH

Insp Date: **2/25/09 11:29 AM**

Location Address: **rear 149 n luzerne ave**

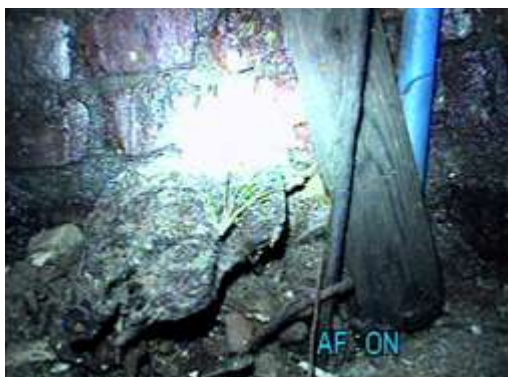
Defect 5

Condition: ☐ Sound ☐ Cracked ☐ Root Intrusion ☐ Deteriorated ☐ Leaks ☒ **Debris**

bench debris

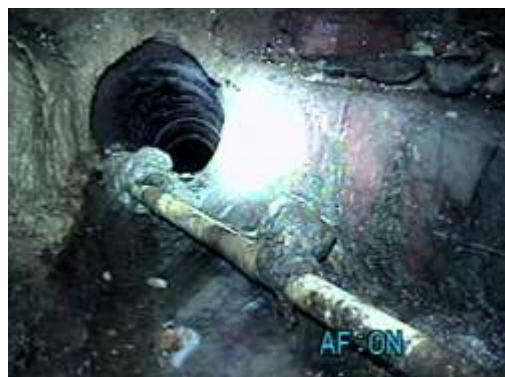
Defect 4

Condition: ☐ Sound ☐ Cracked ☐ Root Intrusion ☐ Deteriorated ☐ Leaks ☒ **Debris**

channel debris

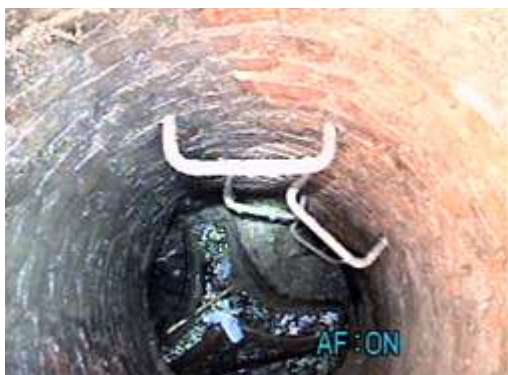
Defect 3

Steps Count: **4** Missing: **0** ☒ **Corroded**

cor. steps

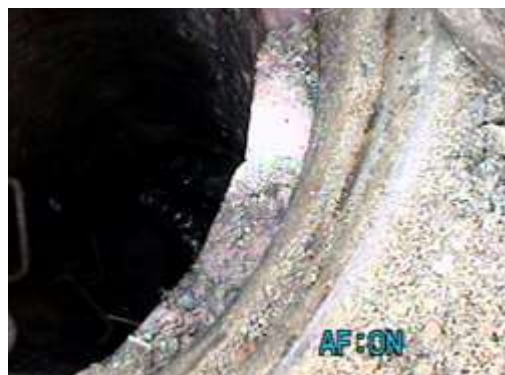
Defect 2

Frame Offset: **2** (in.) Condition: ☒ Sound ☐ Cracked ☐ Leaks

offset

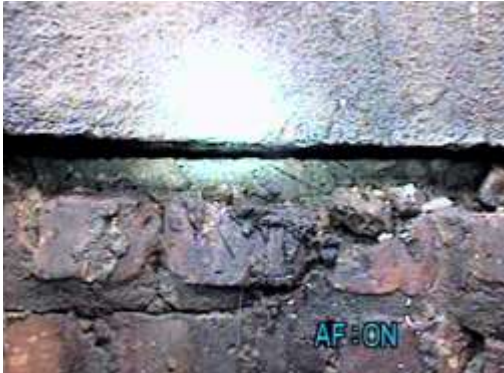
Defect 1

Condition: ☐ Sound ☒ **Cracked** ☐ Root Intrusion ☐ Loose Brick ☒ **Deteriorated**

chimney cracked and deteriorated, frame
adj

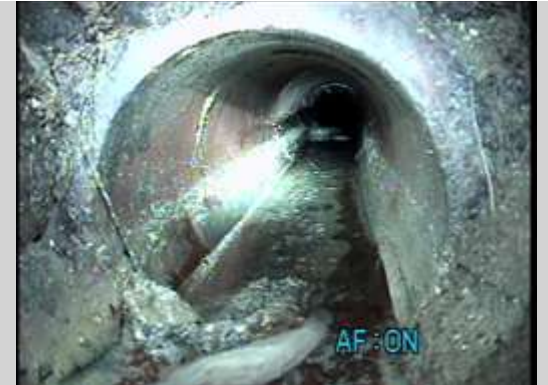
12 O'Clock Outflow

8 in. Circular Gravity Sewer
Pipe Out @ 12 O'Clock

Invert Depth: **9.58** (ft.) Flow Characteristics: **Fast**

Deposits: ☒ None ☐ Mud ☐ Sludge ☐ Debris ☐ Grease

Infiltration: **None** Pipe Seal Cond: **Unknown**

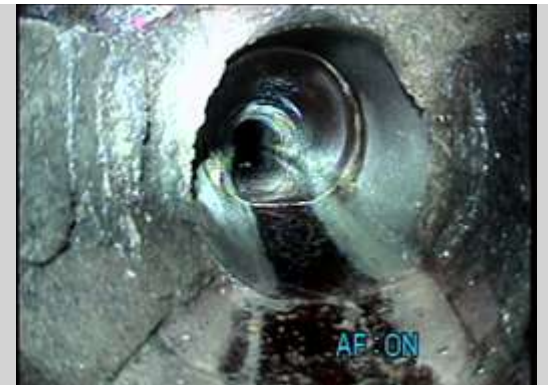
4 O'Clock Inflow

8 in. Circular Gravity Sewer
Pipe In @ 4 O'Clock

Invert Depth: **9.41** (ft.) Flow Characteristics: **Fast**

Deposits: ☒ None ☐ Mud ☐ Sludge ☐ Debris ☐ Grease

Infiltration: **None** Pipe Seal Cond: **Unknown**

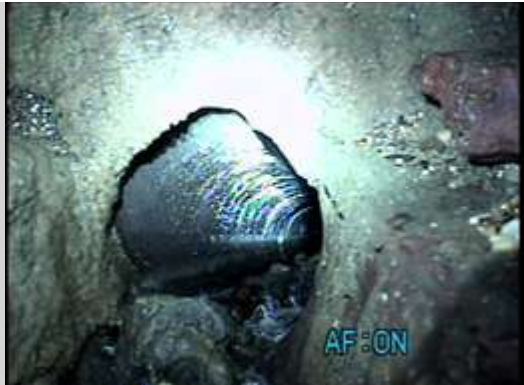
8 O'Clock Inflow

Invert Depth: **9.33** (ft.) Flow Characteristics: **None**

Deposits: ☒ None ☐ Mud ☐ Sludge ☐ Debris ☐ Grease

Infiltration: **None** Pipe Seal Cond: **Unknown**
